September 18, 2014.

FROM: Steve Markman, South Zone Hydrologist, Eldorado National Forest.

SUBJECT: Meadow 09N83-2 (19E01-2) and compliance with Standard & Guideline #100.

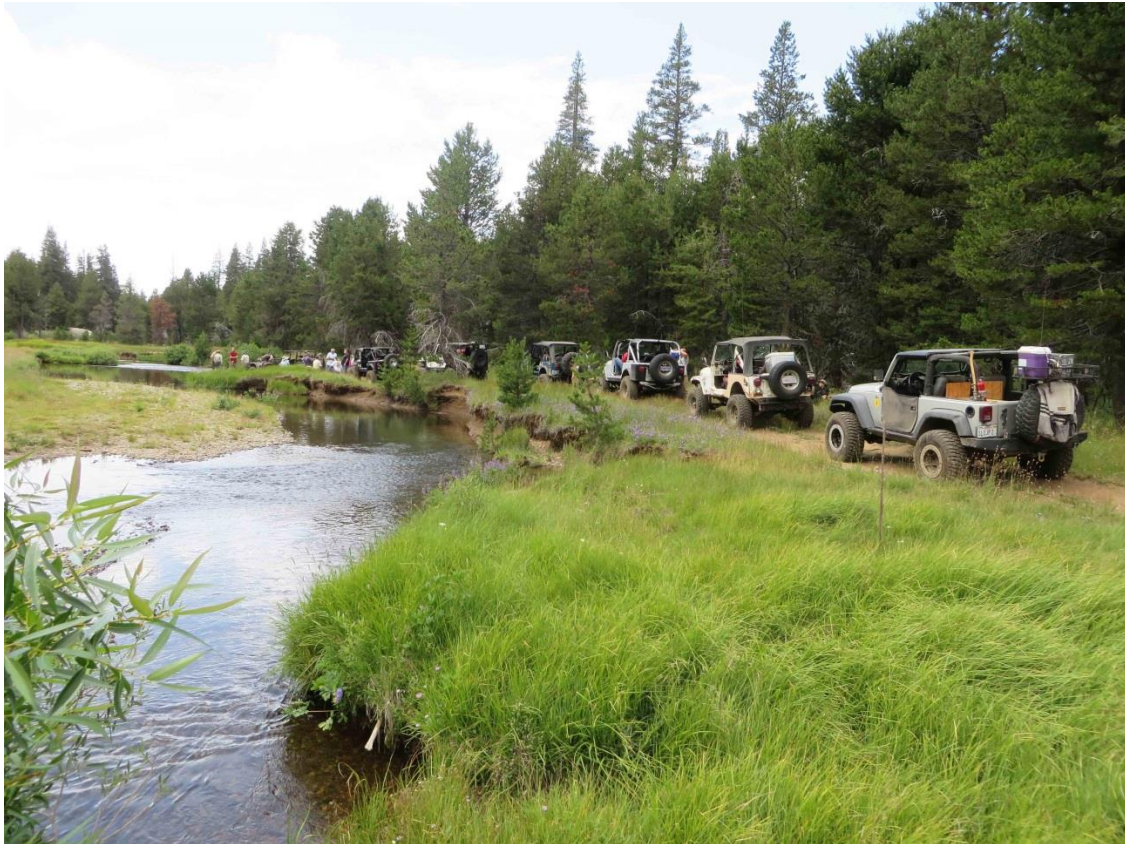
Route 19E01 (09N83) borders a short segment of Deer Creek before crossing the stream, and this segment is less than 30 feet from the stream (Figure 1). Deer Creek flows through the middle of meadow 09N83-2 (19E01-2).

- The channel of Deer Creek is actively re-adjusting itself as the stream flows through extensive alluvial deposits in meadow 09N83-2 (19E01-2). This means that the erosion of the stream channel, particularly at meander bends such as where route 19E01 (09N83) borders the stream (Figure 1), is mostly a natural occurrence and has very little to do with the presence of route 19E01 (09N83). In addition, the erosion of the stream channel at two former and one current

**Figure 1.** A segment of route 19E01 (09N83) borders Deer Creek and meadow 09N93-2 (19E01-2). The erosion of the stream channel at this location is at the outside of a meander bend.
